Brake Wear & Pulsation Investigated

Finally, the whole truth about two major service issues

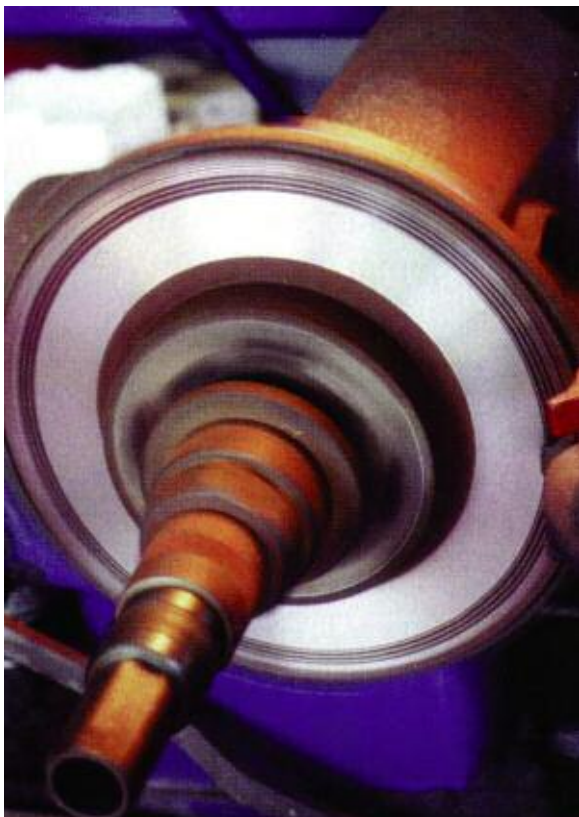
Once, machining rotors at every reline was S.O.P. in most shops. Not anymore.

— It wasn't that long ago that it was standard operating procedure in most shops to automatically turn rotors on a lathe during a reline, providing they weren't down to their legal throw-away thickness. No more, at least among the highest-quality repair facilities. As one successful European car specialist says, "We've gotten rid of our brake lathe. The tolerances on late models are so close, any appreciable wear demands that the rotors be replaced." Also, new discs will be extra insurance against a recurrence of a pulsation complaint simply because they haven't been cut, so are thicker.

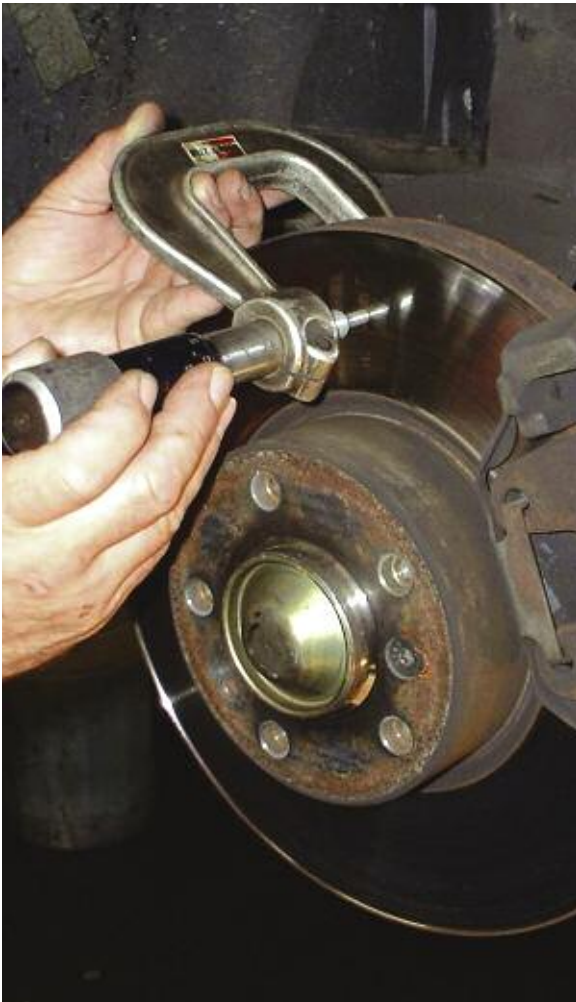
It takes careful measuring to uncover the thickness variation that causes pulsation.

Uncovering DTV requires that you pay attention. Measure thickness at eight evenly-spaced points around the disc.

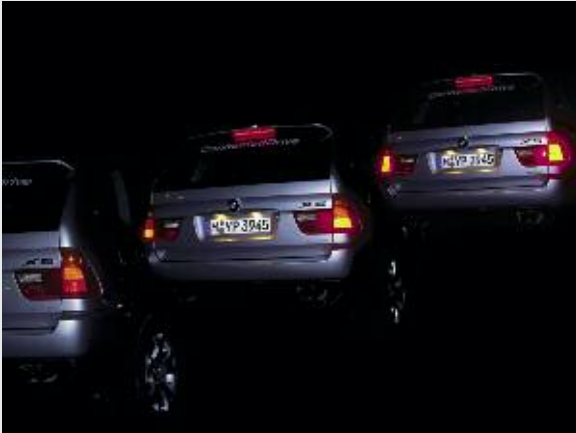
Adaptive Brake Lights

That's the idea behind the adaptive brake lights found on new selected models, but visually. The main taillight units are outboard, and incorporate three-dimensional LEDs for their tail- and brake lights. Additional tail lamps and the backup light are in a light band across the trunk lid. This set-up lets following drivers know how hard you're stepping on the pedal, or if the ABS has engaged.

Under normal braking, the outboard and 3rd brake lights illuminate as usual. During hard braking or when the ABS is activated, the taillights join the brake lights (at the same lighting intensity as the brake lights) for a significant increase in visual warning.

In case of burnout of certain exterior bulbs, a nearby bulb (one normally used for a different function) is "commandeered" automatically until the defective bulb is replaced. The Check Control monitor system alerts the driver to the burned-out bulb.

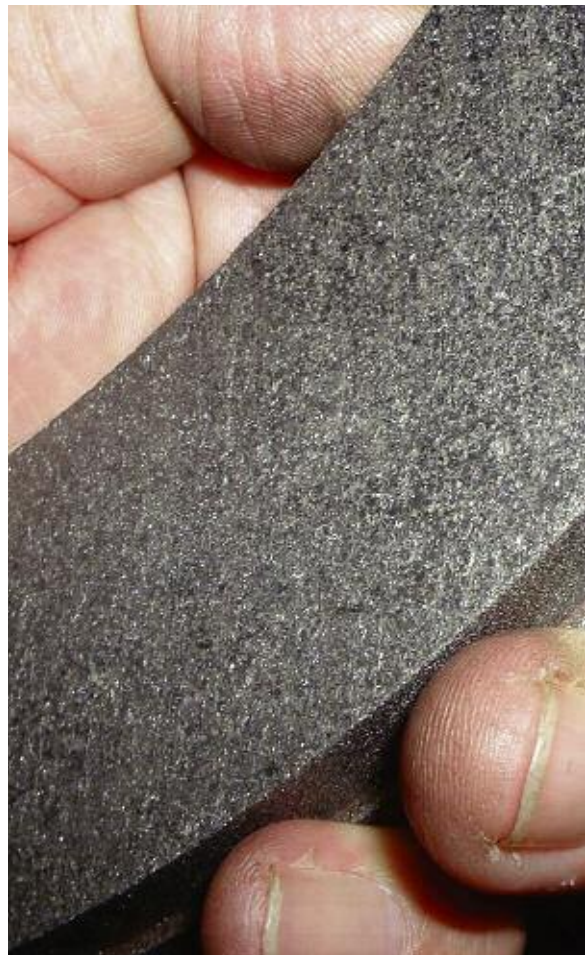
There's a real science involved in formulating lining material to achieve good pedal feel, longevity, etc. If it's too hard, it'll amplify and transmit even the tiniest vibrations.

— No, to get high performance braking you need an aggressive, up-to-date lining recipe and sophisticated metallurgy in the rotor, both matched to the application, and this is the approach BMW engineers have taken. The trick is in balancing lining and rotor wear against stopping power and pedal feel, and compromises come at the expense of wear, which is just as it should be.
